Phase I Inspection Report

Mt. Beacon Reservoir

Hudson River Basin, Dutchess County, New York

30 September 1980

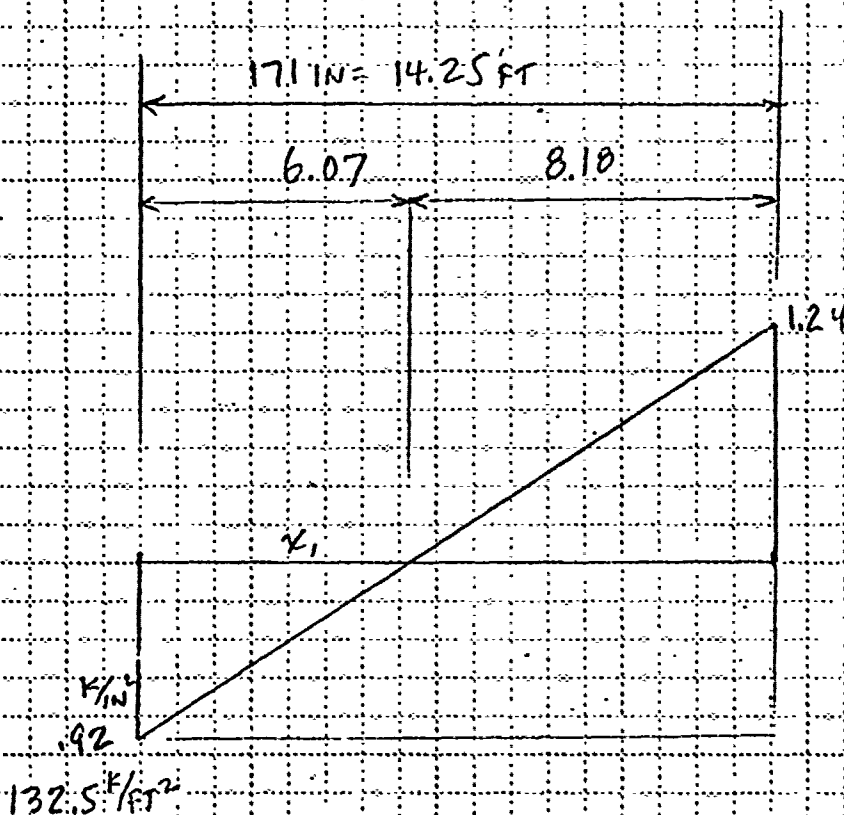
Job No. 1551-04 TIPPETTS-ABBETT-McCARTHY-STRATTON
 ENGINEERS AND ARCHITECTS NEW YORK
 Project BEACON RESERVOIR
 Subject STABILITY ANALYSIS NON OVERFLOW MONOLITH
CASE 5

FIRST TRIAL - Base assumed 100% in compression
calculations indicate a sliding F.S. = 1.04,
^{pressure}
~~rock~~ on rock = 133 kip per square
foot and a very small percentage of
the base in compression. A second
trial with a revised uplift diagram
would indicate less favorable
results. The section is inadequate
for case 5.

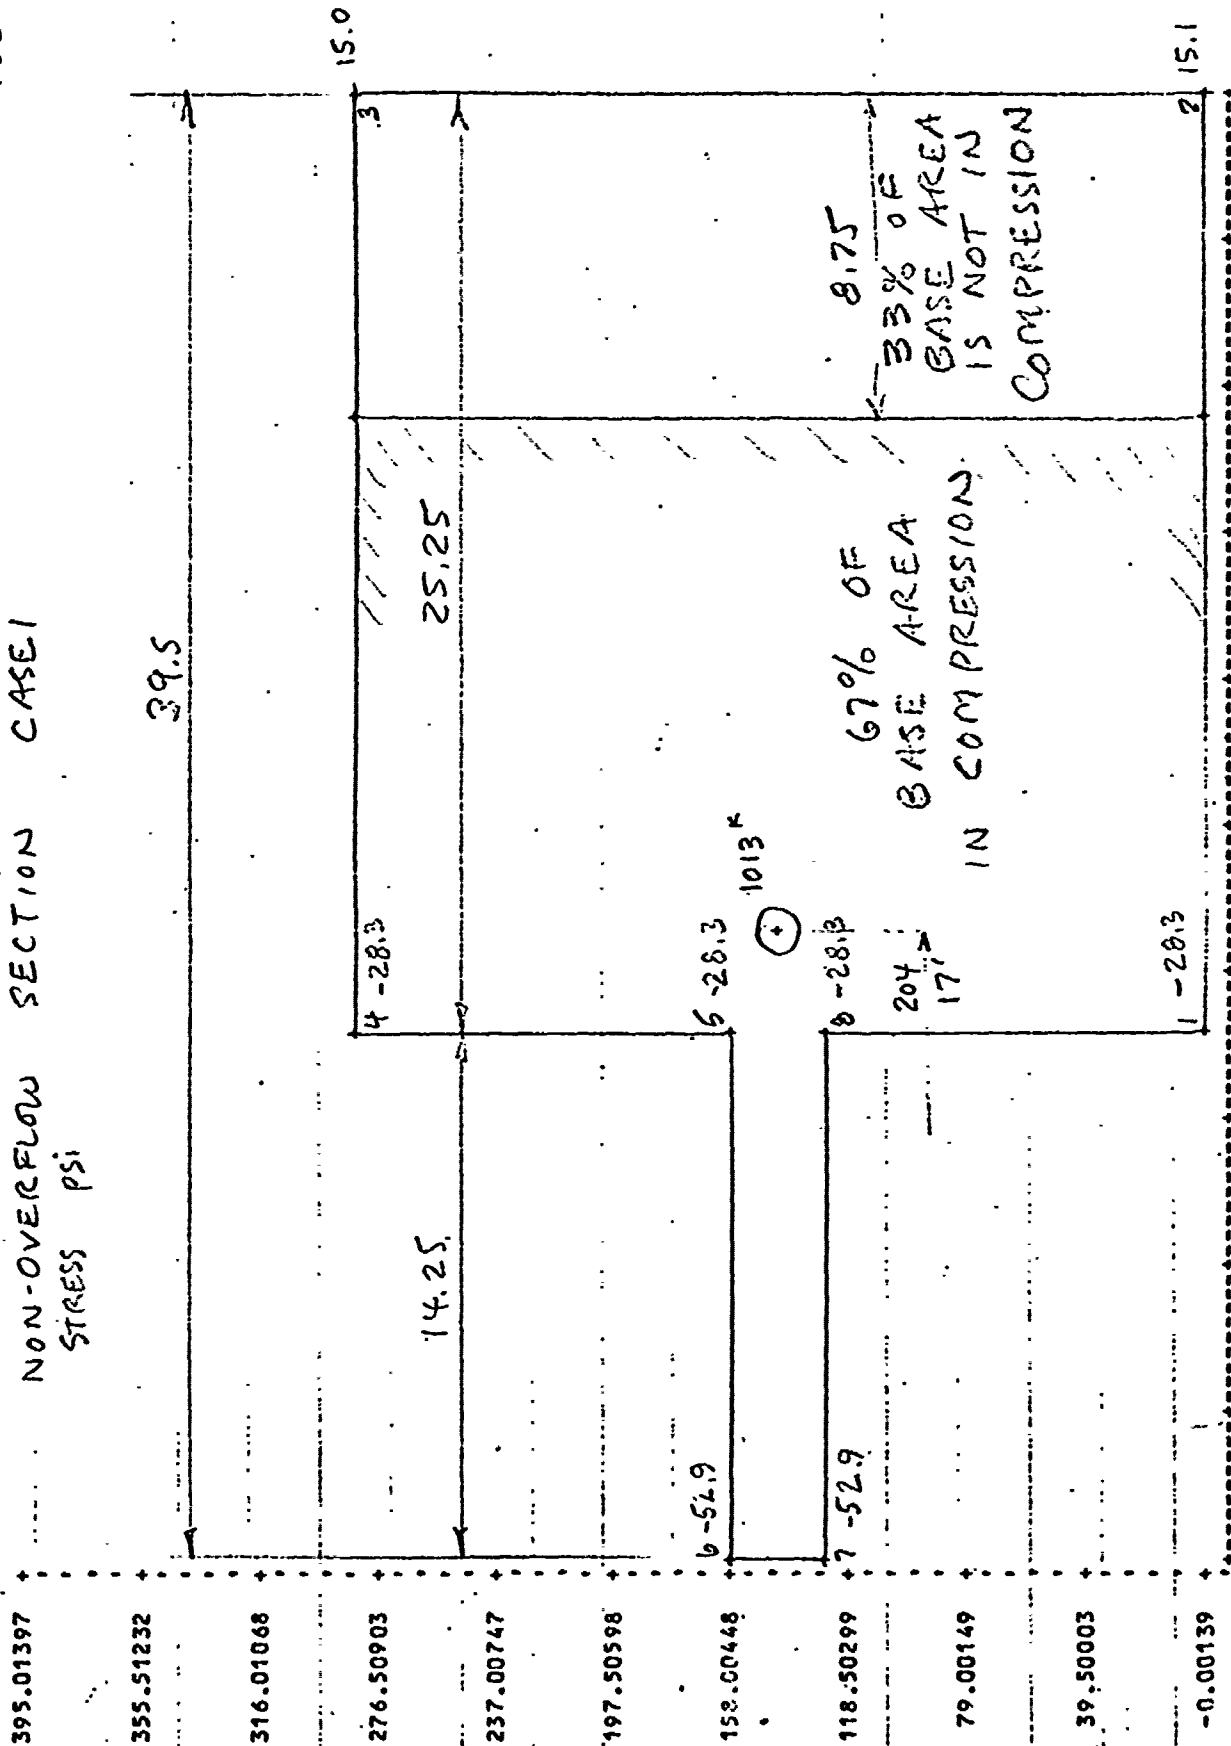
DAM CITY OF BEACON, N.Y.
NON-OVERFLOW SECTION CASE 1
STRESS PSI

Calculations indicate that, with this assumption, only 67% of base area is actually in compression and sliding F.S. = 1.21. These results indicate that the section is inadequate ^{for CASE 1} especially since a second trial would produce a lower percentage of base in compression and a lower sliding F.S. A revised uplift diagram would decrease the vertical load and reduce the stabilizing moment.

The base area should be 100% in compression for the normal loading condition.

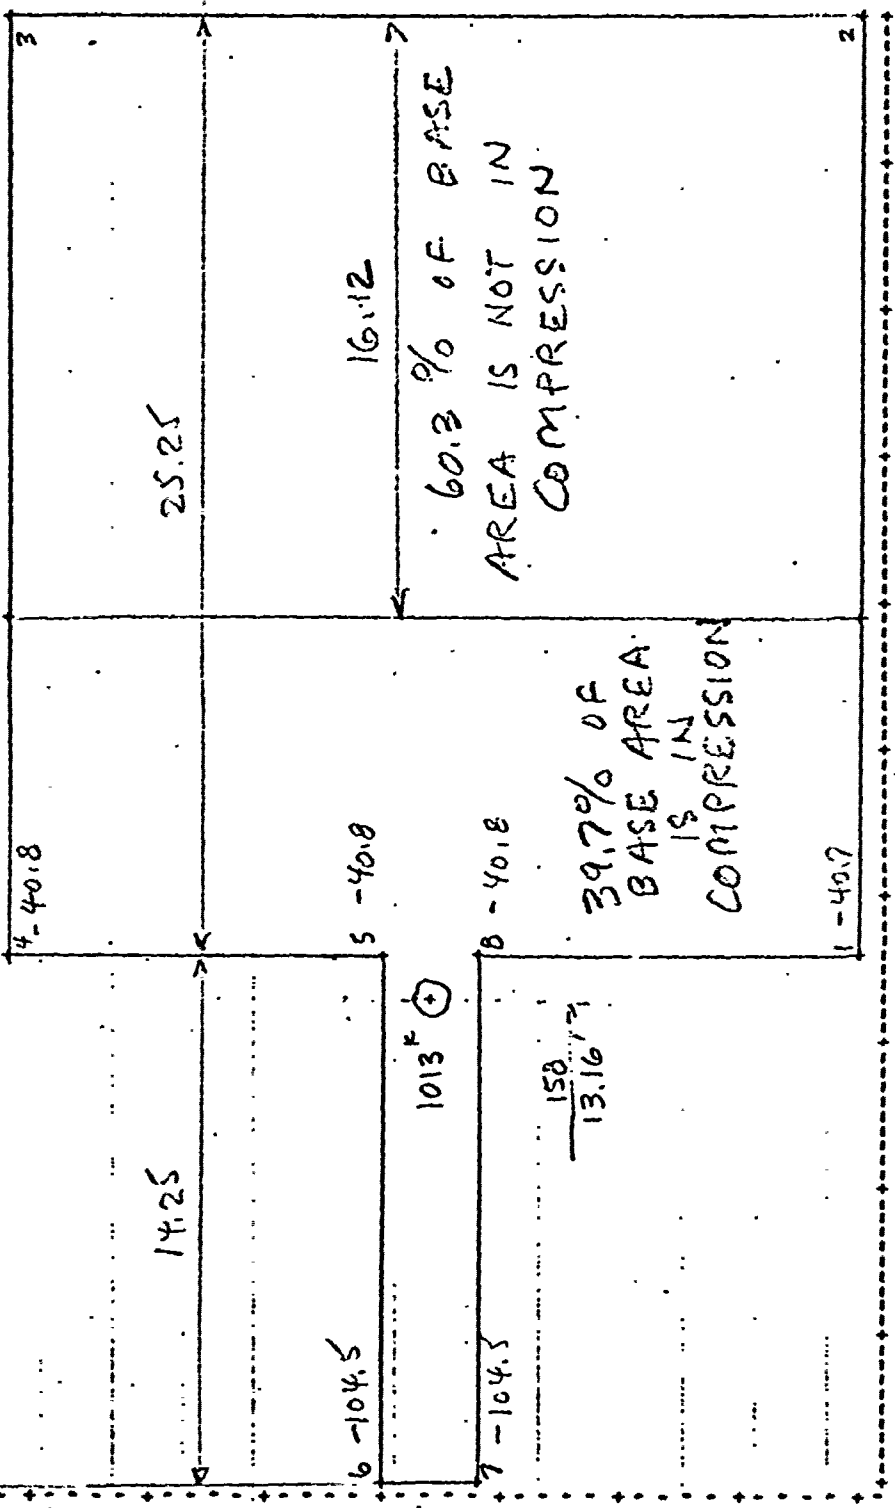
FIRST TRIAL: With base area assumed 100% in compression, calculations indicate that only 39.7% of base area is in compression and sliding F.S. = 1.06. These results indicate that the section is inadequate for CASE 2. See comments to case 1.

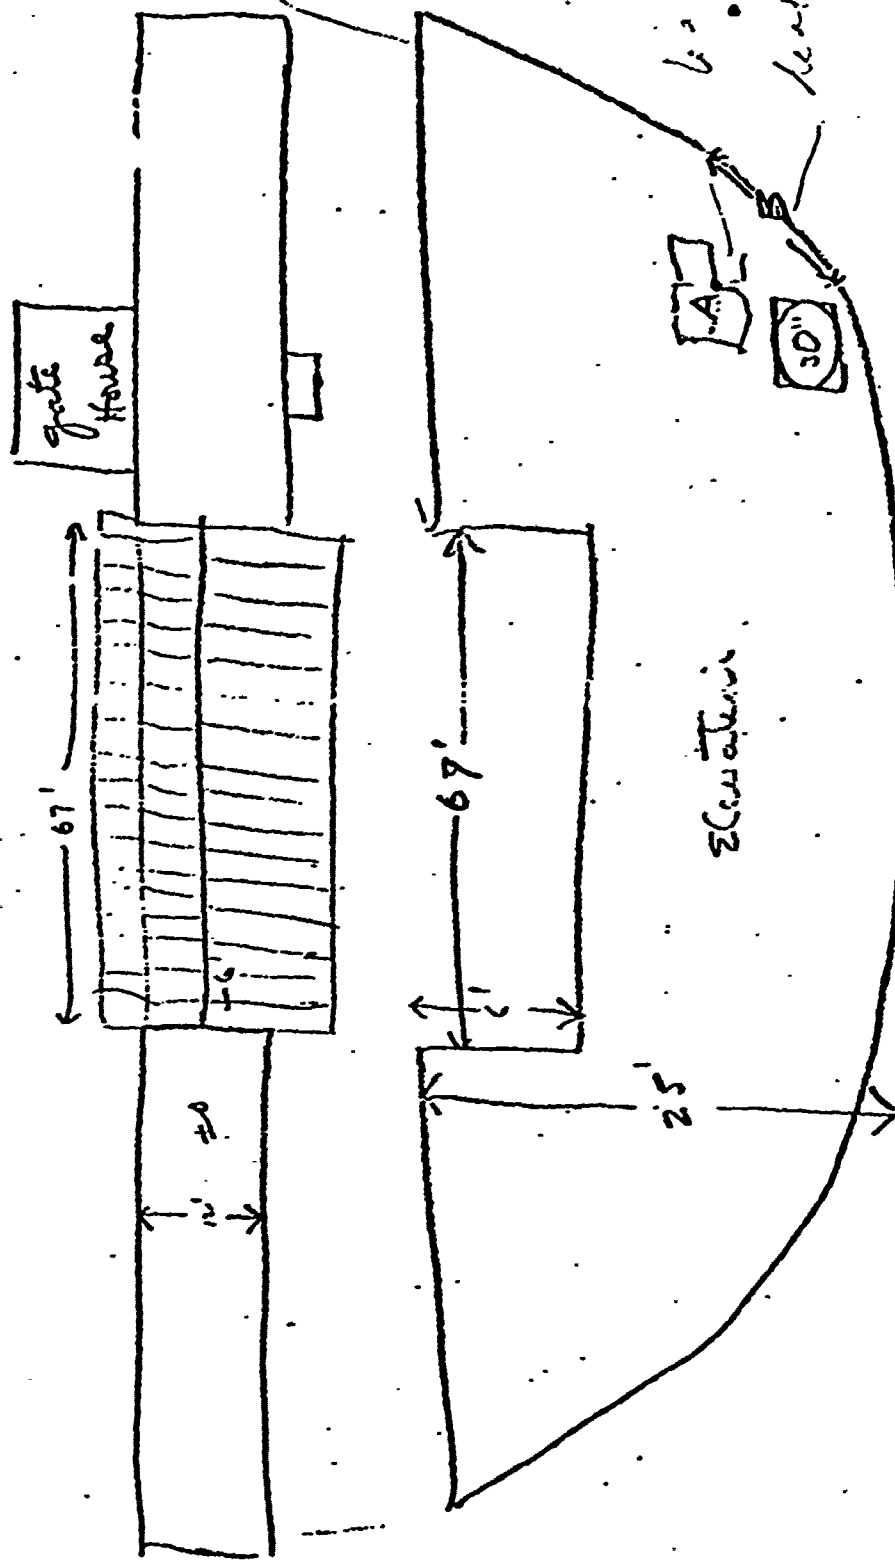
Surface of concrete is spald
 Some leakage near spillway about 18"
 below crest

A - Small run of water - a

B - along this section there is a little sewer
